ControlSEAL Resin Sealant

Liner Plug and Squeeze

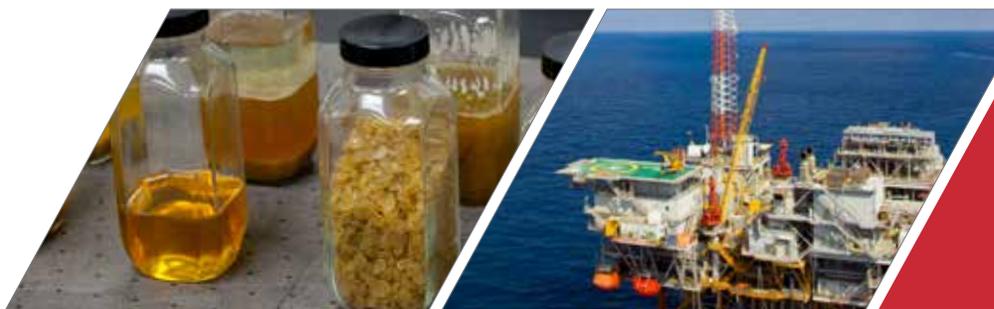
WELL INFORMATION

Prev. Casing: 13³/₈ in., 72 lb, N-80

Prev. Casing Depth: 2,417 ft

Liner: 10³/₄ in. 45.5 lb, P-110

10³/₄-in. Drillable BP: 2,351 ft

TOC on CIBP: 2,341 ft

Casing Cut: 2,339 ft

Top of Resin: 2,305 ft

Workstring: 2⁷/₈ in. , 8.7 lb, N-80

Retrievable Squeeze Packer: 2,225 ft

EOT: 2,285 ft

Well Fluid: 8.34 ppg Fresh Water

BHT: 100°F

To keep from running a smaller liner, Wild Well was contacted to pump ControlSEAL™ resin sealant to repair the leak between the 10³/₄-in. liner and the 13³/₈-in. casing. Due to the low BHT and the unique well conditions, the heat from the resin reaction needed to be

kept to a minimum. The resin used was designed with an extremely long set time for it to be squeezed into place over time and to reduce the temperature of the exothermic reaction. It did not use any weighting agents as it was not necessary since the wellbore fluid was fresh water. The resin reaction temperature stayed below 150°F and it remained pumpable through 36 hours. The compressive strength was 3,600 psi after 7 days and 6,100 psi after 23 days. A CIBP with cement on top was placed in the 10³/₄-in. liner with TOC at 2,341 ft. The liner was cut just above the TOC. Wild Well mixed 4 bbl of ControlSEAL and BJ Services displaced it into the well through the 2⁷/₈-in. workstring. The resin was mixed and pumped successfully and without any issues. After the resin was displaced to the TOC, Baker Hughes set a retrievable packer above the resin and BJ applied 3,000 psi of squeeze pressure through the 2⁷/₈-in. workstring. A squeeze pressure of 3,000 psi was maintained on the resin for

72 hours to push it behind the liner through the liner cut to seal the leak. After 11 days, the top of the resin was tagged 4 ft below what was expected, which indicated some of the resin was injected behind the liner. Then the resin, cement, and bridge plug were drilled out. Pressure tests with nitrogen confirmed the leak had been repaired and the well was put back to use.
